# An Analysis of Infrastructure Conditions and Pedestrian Safety in Capitol East

### **An Analysis of Infrastructure Conditions and Pedestrian Safety in Capitol East**

Prepared for the Neighborhood Development Division  
Office of Community Development  
City of Des Moines

May 2014

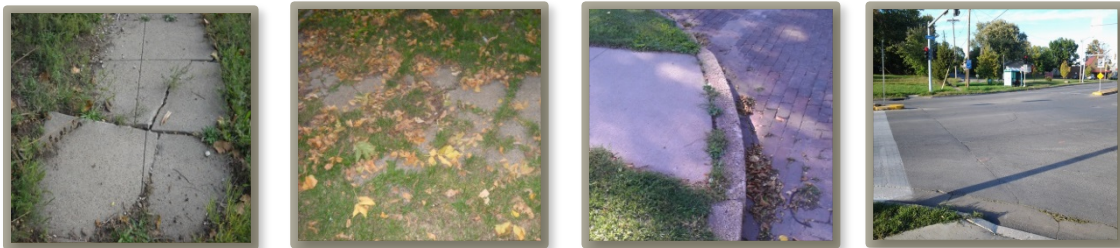
**From left to right: cracked sidewalk, overgrown sidewalk, no curb cut, no crosswalk infrastructure**

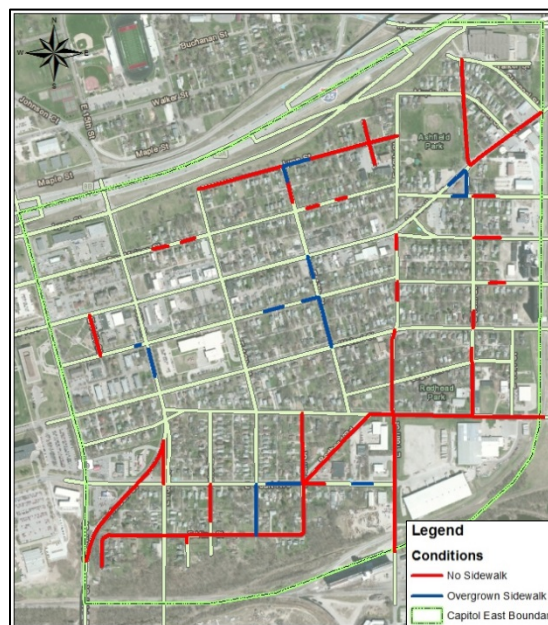
**Figure 5. Missing or Overgrown Sidewalks**

Overall sidewalk conditions that were missing or overgrown encompassed 23% of the entire Capitol East neighborhood, of which 18% were missing sidewalks and 5% were overgrown. Most of the missing sidewalks occur along the northern, eastern and southern periphery of the neighborhood. Additionally, most of the notable crosswalk issues occur in areas with the most well developed sidewalk infrastructure. It should be noted that although the team did not track exact numbers on how many sidewalks are made of brick, observations showed that most of the overgrown sidewalks were brick. See Figure 5 for a map of where problematic sidewalk conditions are located.

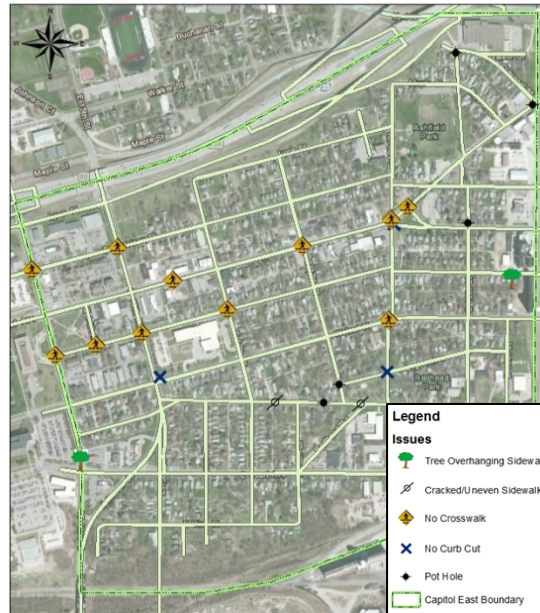
**Figure 6. Miscellaneous Sidewalk Issues**

Our visual inspection of sidewalk conditions in Capitol East revealed a total of 23 issues in 5 categories: tree overhang, cracked or uneven sidewalks, no crosswalk, no curb cut, and pot holes. Of the 23 issues, over 61% of them were focused on crosswalk infrastructure (lack of crosswalk paint, lack of crossing signs, no curb cuts). Potholes accounted for 22% of the issues,

and tree overhangs and cracked or uneven sidewalks constitute the remaining 17%. Figure 6 provides a map of where each problem was located.
